SARASOTA NATIONAL

**BOARD OF SUPERVISORS
REGULAR MEETING
AGENDA**

DISTRICT STAFF COMMUNICATION TIMELINE FOR WAVERLY CIRCLE LAKE 32 BANK RESOTRATION
PROJECT

Sarasota National CDD
LAKE 56 SITE VISIT

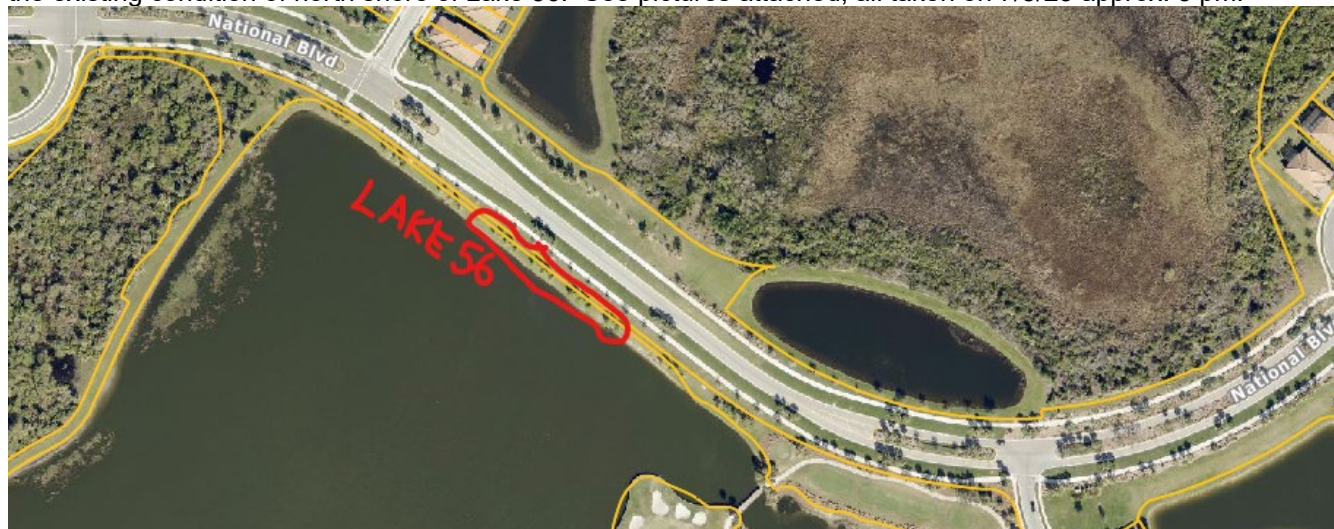
After the CDD Meeting where a Lake 56 north side erosion issue was discussed, a site visit was conducted to observe the existing condition of north shore of Lake 56. See pictures attached, all taken on 7/8/25 approx. 3 pm.

It is the opinion of this engineer that there is not an imminent danger or extreme condition of failure of this lake bank that would compromise the National Blvd Roadway or the multi-use pathway on the south side.

This bank erosion has occurred over months/years. There can be several contributory factors from wave-action, the drip irrigation system for the tree clusters, overland storm flow, wind/rain forces, seasonal soil matrix cycles (wet season vs. dry season), rise/fall of Lake 56 during cycles of the year, etc.

All tree clusters seem resilient to the erosion occurring at their root system, but their vertical plumb position is being compromised. Even though a couple of the trees (see pictures attached) have totally compromised soil/root balls, they have maintained some verticality for now. Over time, when left untreated, these trees can be compromised.

One of the more predominant factors may be the irrigation system directly on the tree clusters, especially if any of the system is malfunctioning and providing a point discharge to the tree cluster. This irrigation routine concentrated 'point load' could have affected the stability of the lake bank and compromised the compaction of the soil in/around each root system of the tree. This irrigation system in/around the Lake 56 tree clusters should be monitored often.

These trees and root systems can be classified as mature & established. There is an approach where the scheduled irrigation may be modified & only needed during dry season, if this practice is not already implemented.

Recommendation: There needs to be a discussion about whether Lake 56 visibility factor (being adjacent to National Blvd) requires special lake bank treatment. Can the compromised lake bank be remedied with Rip Rap treatment? Or does it need to be re-established as original finished with sodded lake bank all the way to the water line, to maintain visual aesthetics?

Rip Rap Lake Bank Remedy	Sodded Lake Bank Remedy
Cost will be less than Sodded O&M Long term costs: Yearly monitoring Aesthetic: Visible from National Blvd, non-conforming to other Lake 56 bank Method: Geofabric underlay, build up lake bank to slope with Rip Rap (6" minus stone), sod disturbed area	Cost will be more than Rip Rap O&M Long term costs: weekly/monthly landscaping Aesthetic: Consistent with existing Lake 56 lake bank Method: Reinforcement underlay (i.e. geotube, Sox, etc.) Build up lake bank to slope, sod placement

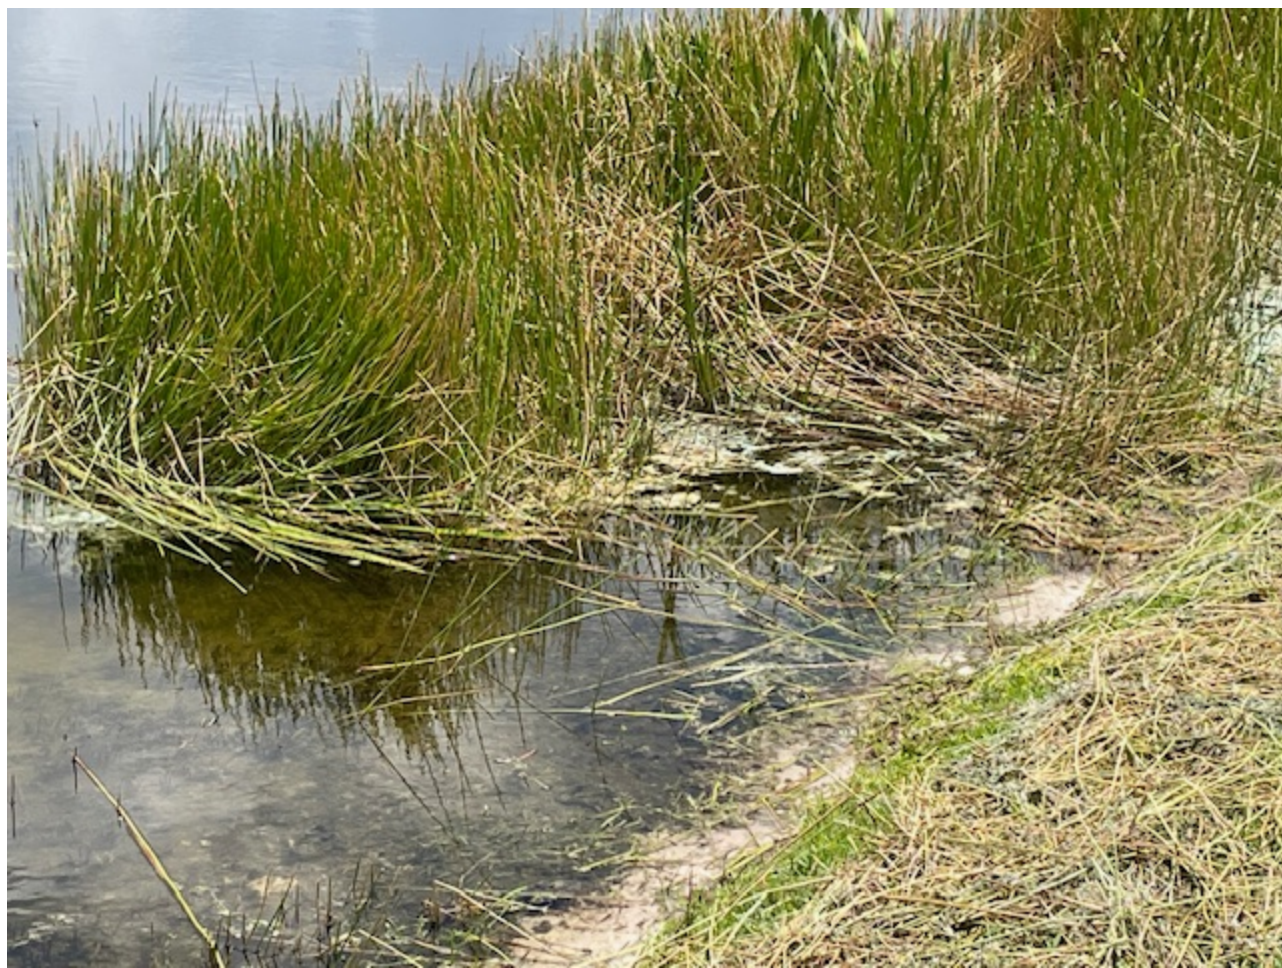
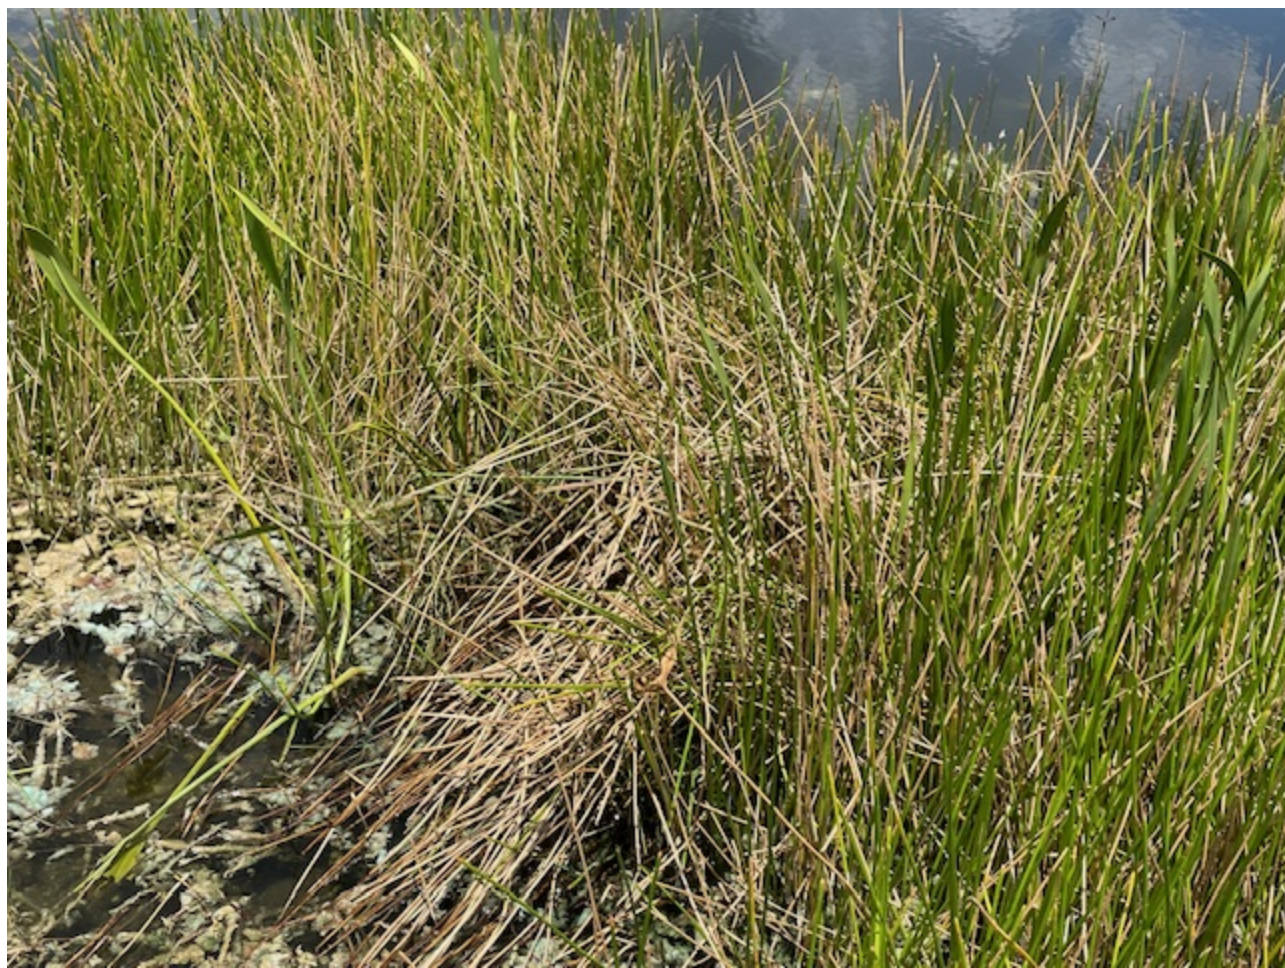
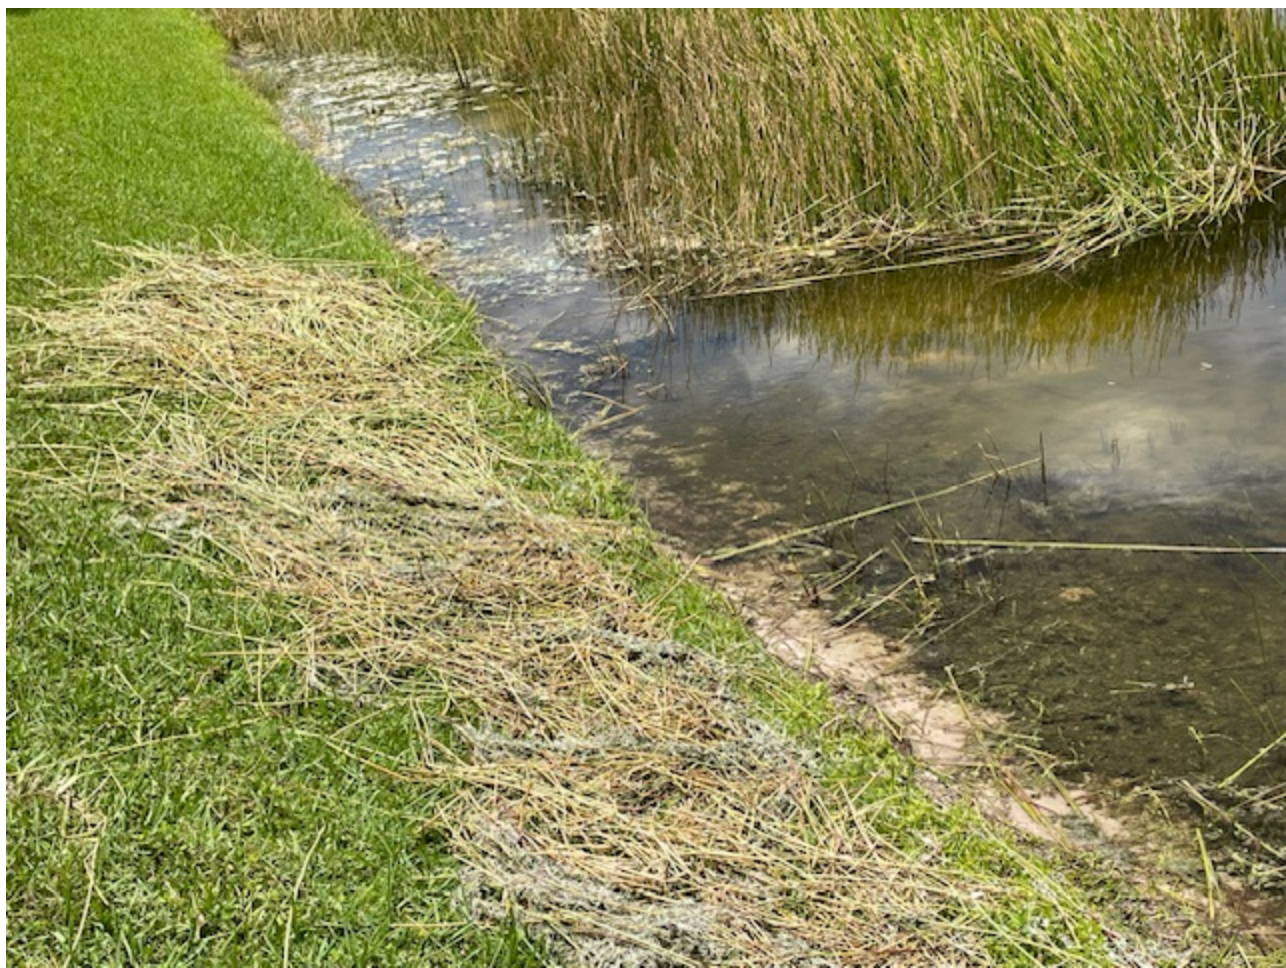
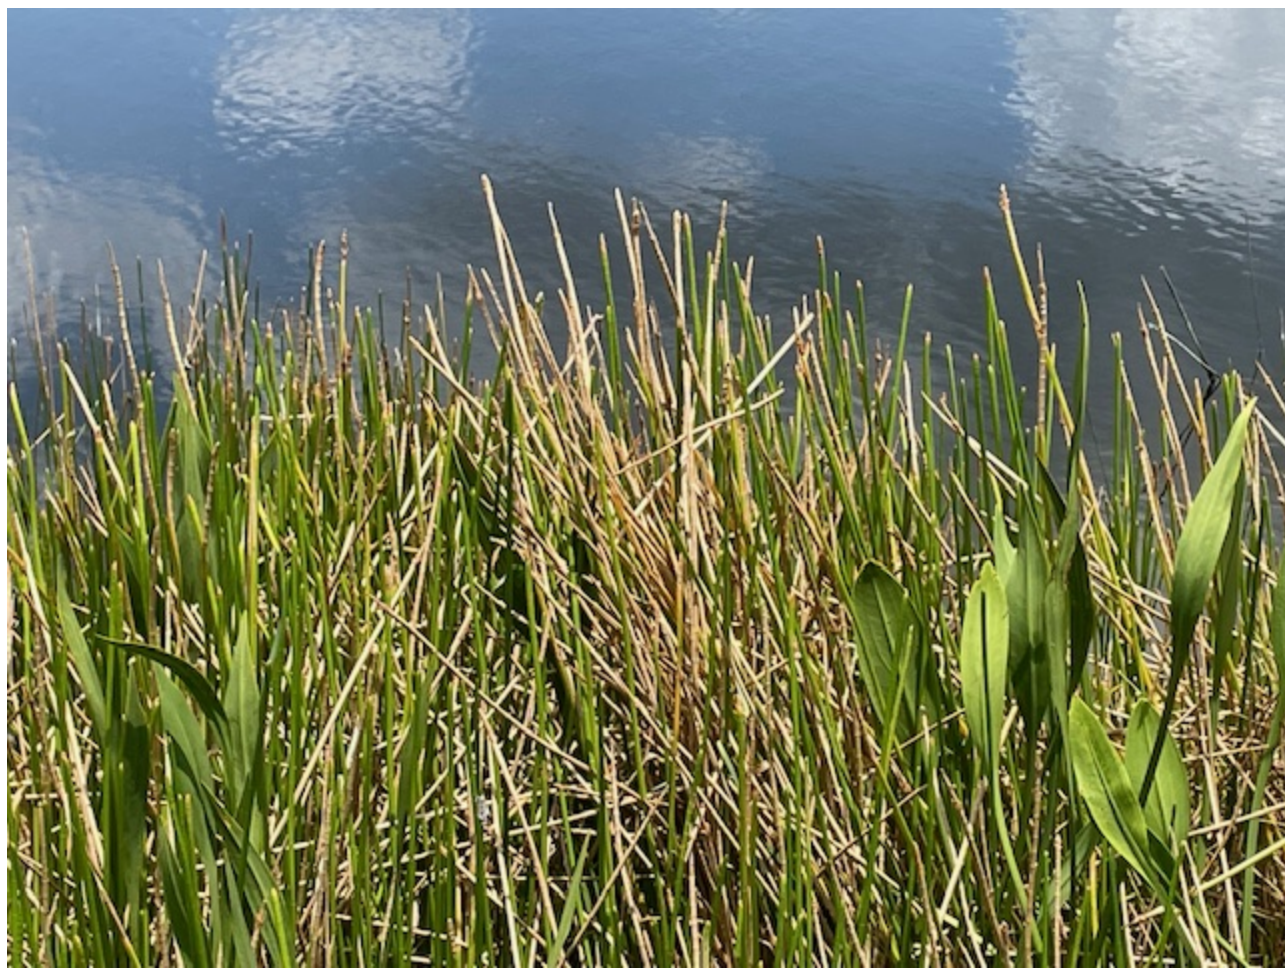
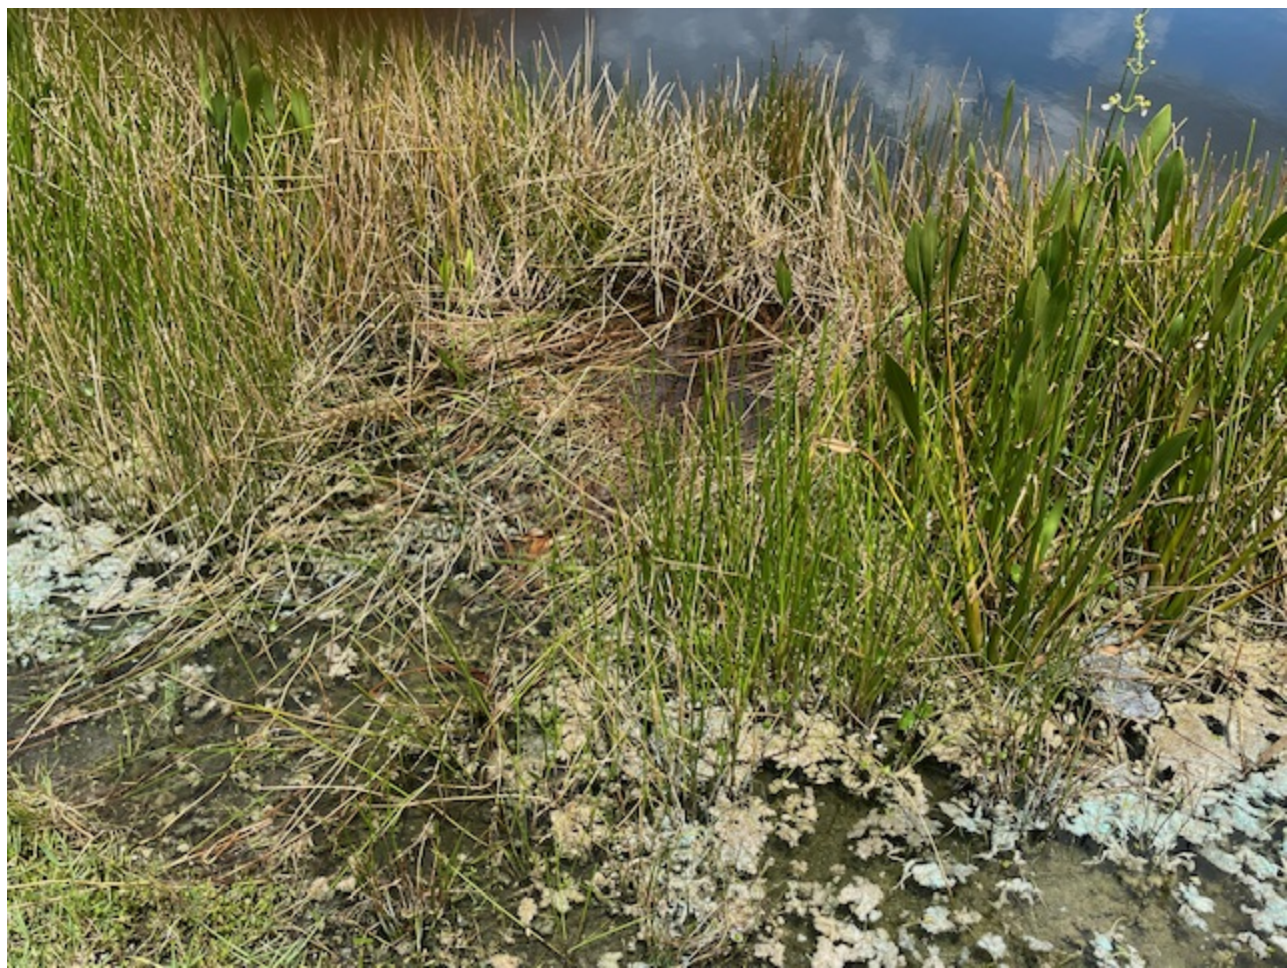
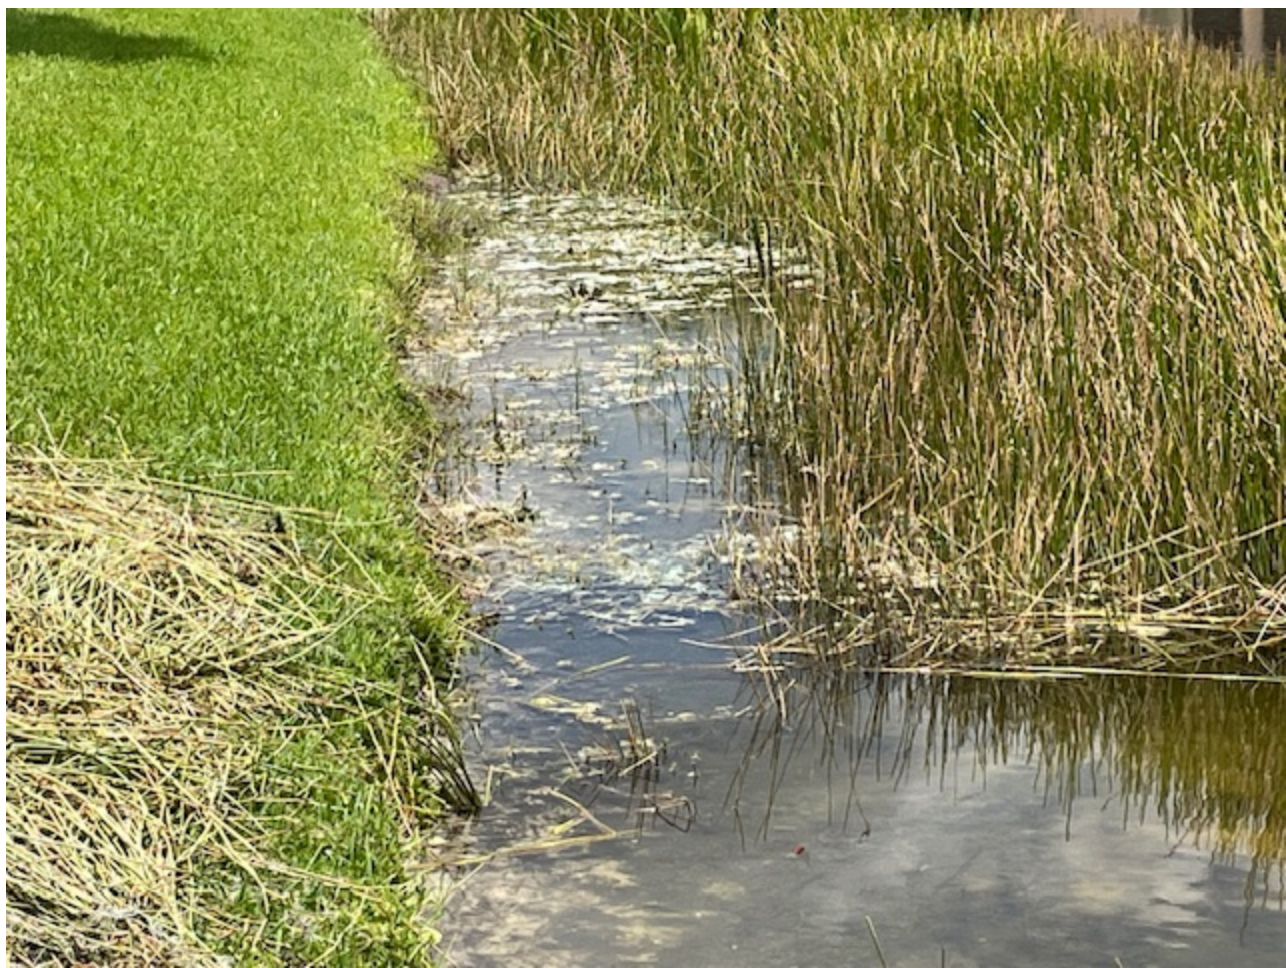
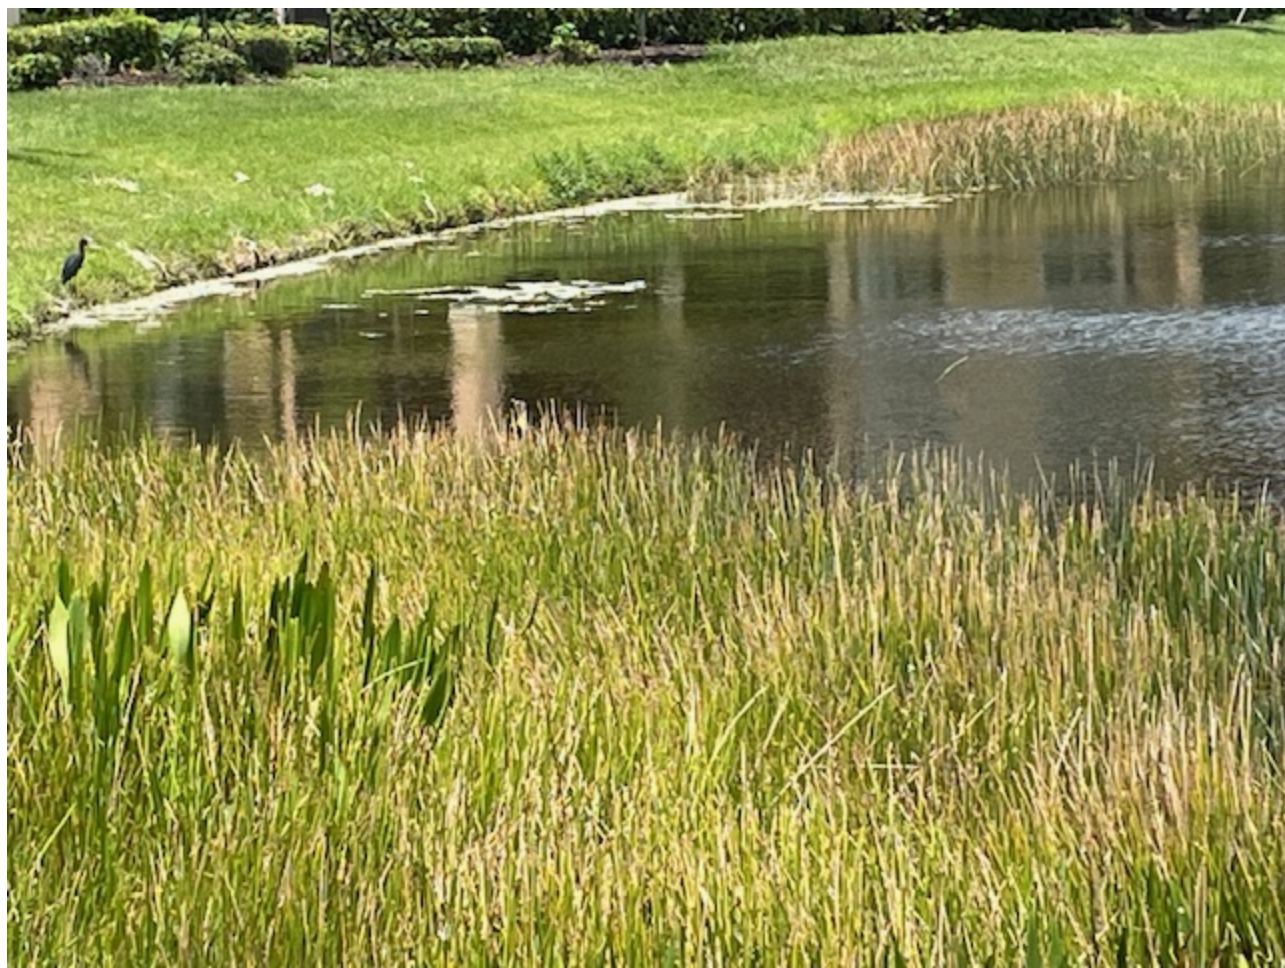
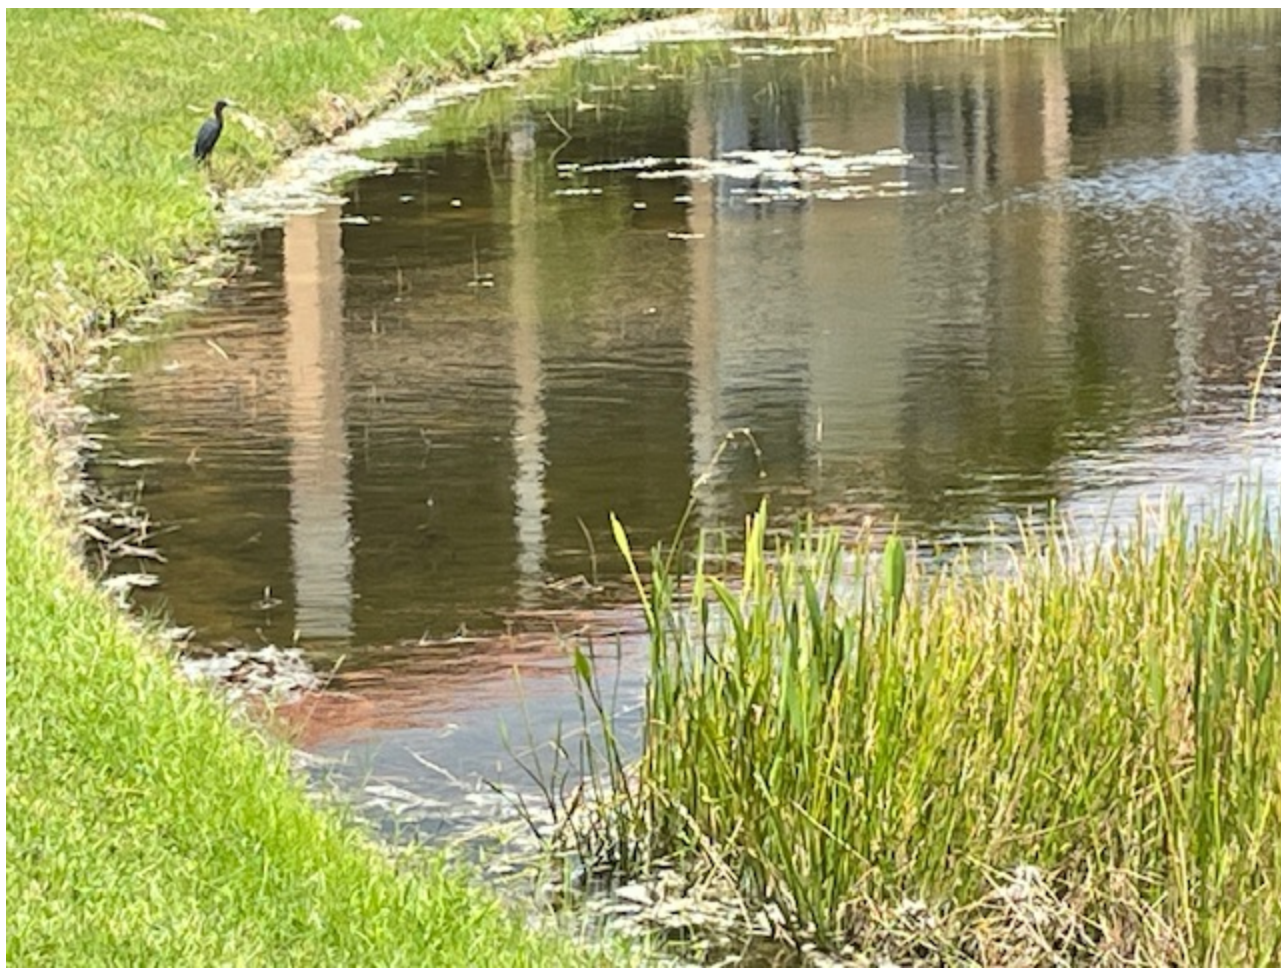
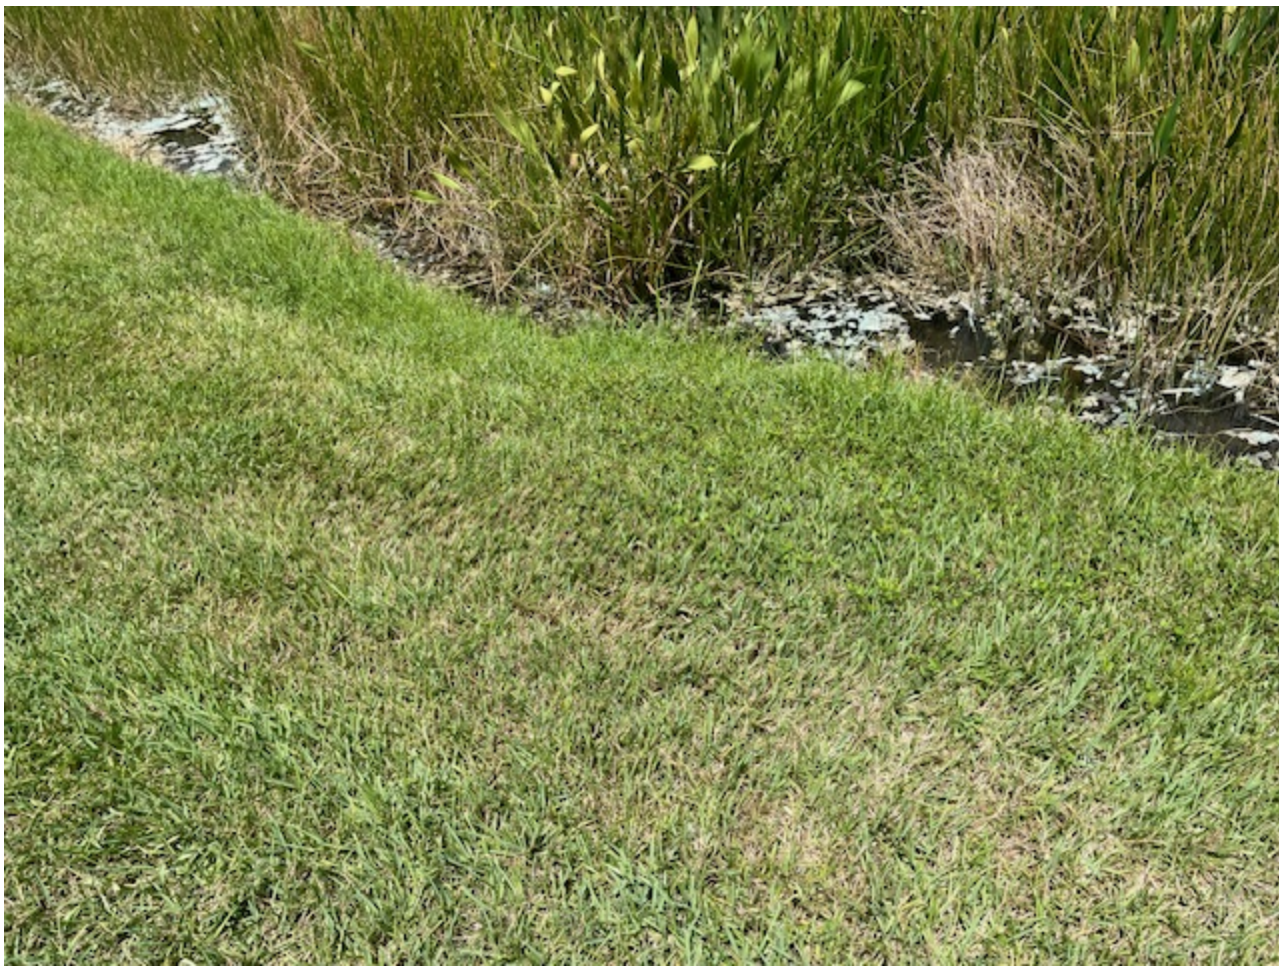
This all happened on lake 25 with the first 3 quads on the right side of Awabuki. Some littorals recently cut, other areas the littorals are completely gone. Only one person answered their door, claiming had no idea who would cut littorals in her back yard. Time for another tutorial, or notifying SN manager about proper etiquette around our lakes for all lakefront residents.
